Restoration in Ethiopia – presentation of a pilot project and a preliminary inventory of damage

Presentation of the pilot project

A preliminary report from 14 Ethiopian Orthodox churches

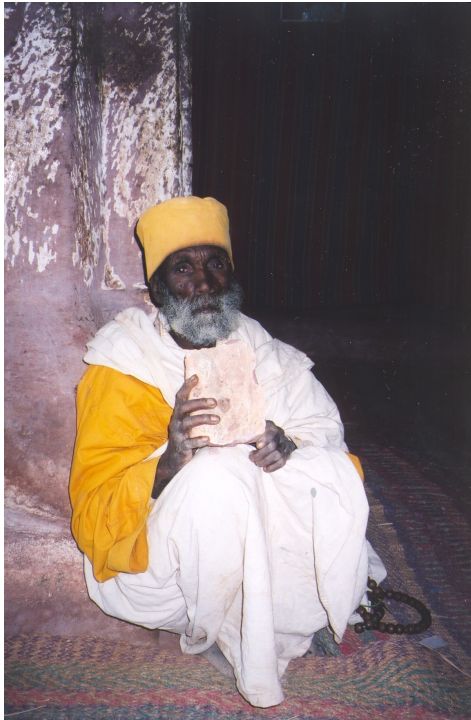
Abba Gäbrä-Sellasié in the rock-hewn church of Debre Tsion Abraham, Tigrey, Ethiopia.

This image depicts the old priest, abba Gäbrä-Sellasié, sitting in his church, Debre Tsion Abraham. This is a rock-cut church, situated at a height of more than 2000 metres in the breathtakingly beautiful landscape of central Ethiopia. The church was hewn out of the mountain sometime during the 13th century. There are more than a hundred such churches in the same area. Debre Tsion Abraham has pillars and vaults and is richly decorated with murals dating from the same era, executed in a style typical of Ethiopian sacred art of the time. Abba Gäbre is obviously distressed by the chunk of plaster in his hands which has recently fallen from the heavily damaged roof. This church is a piece of Ethiopian cultural history, but the stone has started to decompose and the painted plaster is disintegrating.

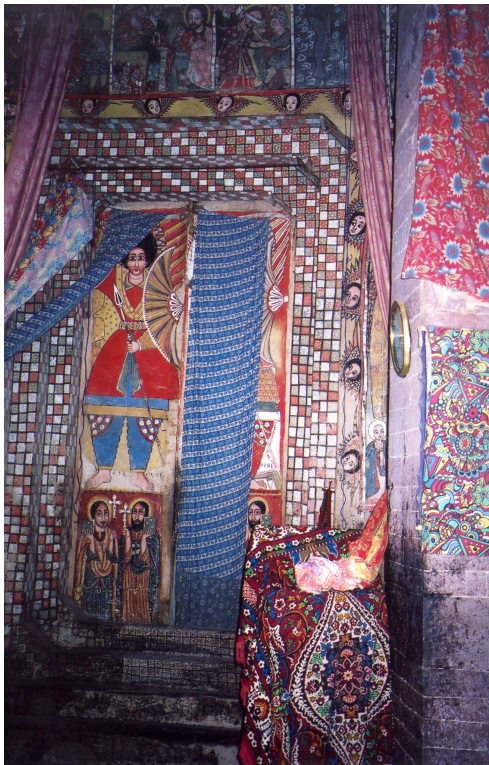
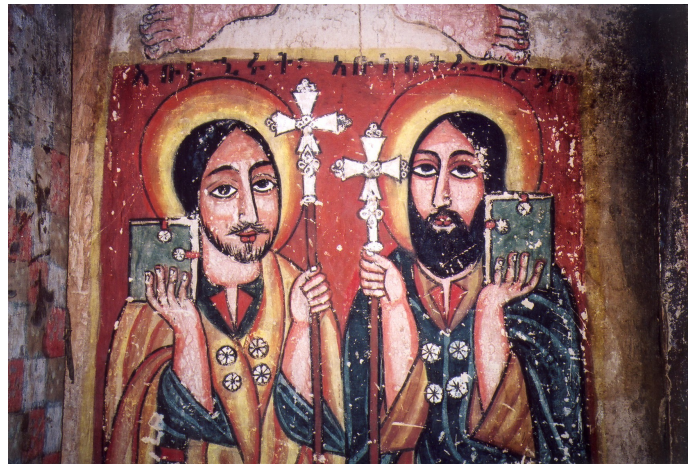
Two saints. The paint is falling off. Detail from the former photo.

Maqdas' west side, painted gateway.

Some of the paintings here are very dirty and the damage is extensive. In some places there are holes that go straight through the canvas and the plaster. In other places the canvas has come loose from the wall and is hanging free. Here is also al secco-painting on plaster in great need of cleaning as well as refastening and retouching.

1. Fixing plaster/canvas and colours.
2. Removal of all old surface treatments, varnish on canvas; wax on plaster.
3. Cleaning of all surfaces.
4. Retouching and repairing where colour and plaster are missing. Repairing canvas where necessary. Replacing wood where needed.
5. Possible new surface treatments.

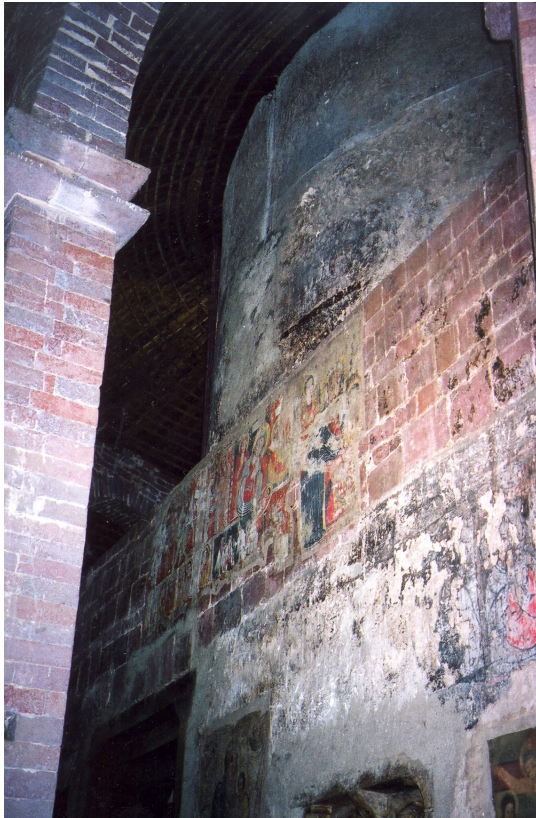
The paintings are very dirty and the damage extensive. In many places and to a great extent the canvas has come loose from the wall and is hanging free. On the murals, paint is falling off and colour flaking is also taking place.

Maqdas' north face. The painting is coming loose.

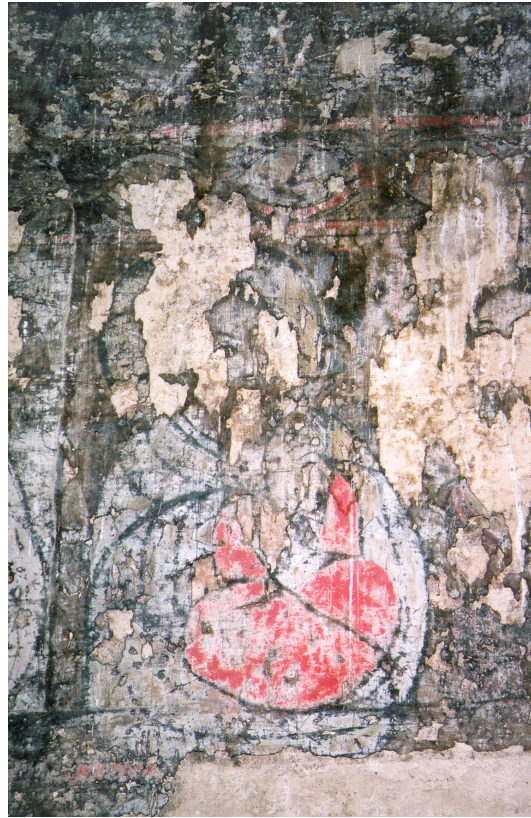
Detail of the former photo.

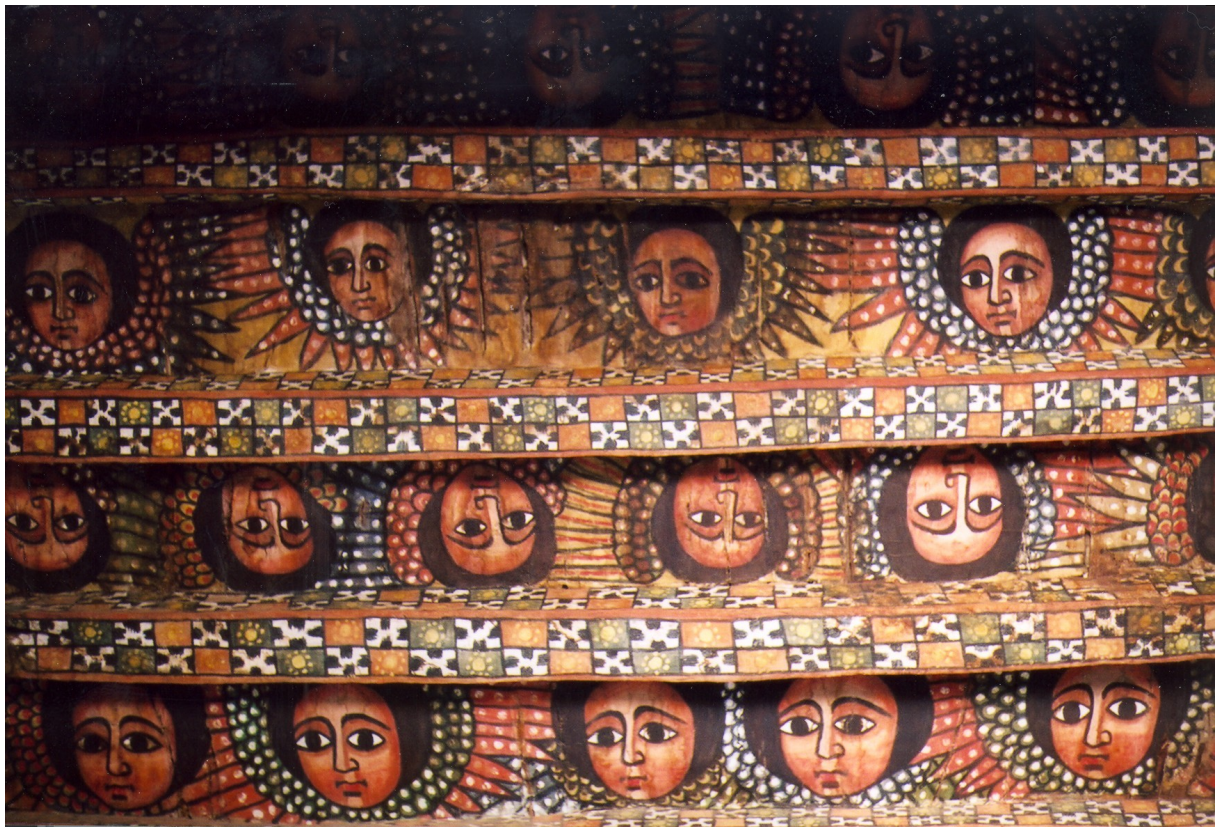
The paintings are in general very dirty and the damage partial, but serious. Paint is falling in several places and beginning to flake in others. There is extensive water damage in the painted ceiling and the straw covering of the roof seems not to be in the best condition.

Cherub paintings on the ceiling are very damaged by water.

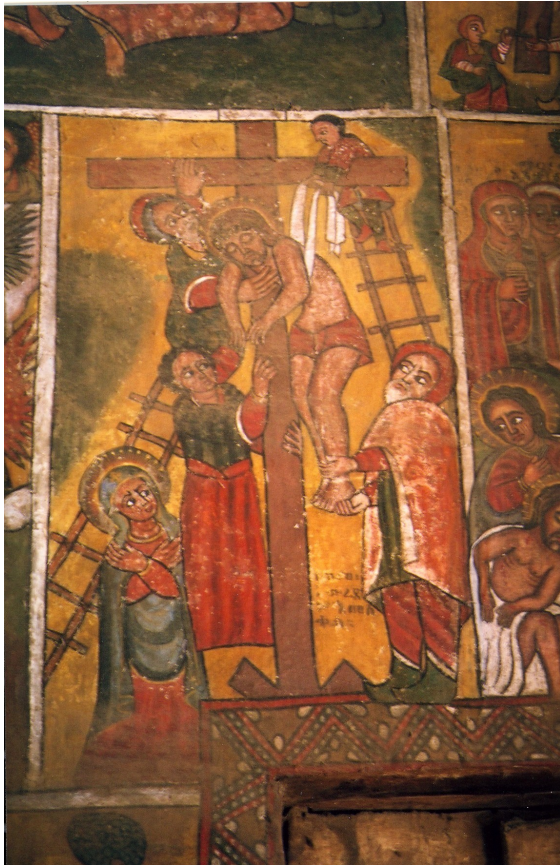
The Crucifixion, western wall. Very dirty. Colour flaking.

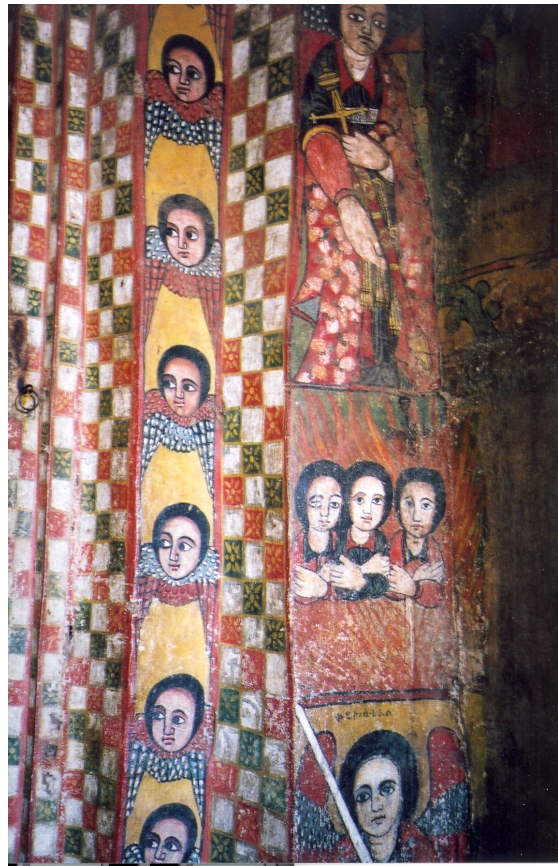
The wall of the choir, right side. Relatively clean. Colour flaking.

The paintings are relatively clean. However paint is falling off and paint flaking may well occur. The older paintings have sustained small amounts of damage. The straw roof is newly done and in good condition, lying on reinforced plastic.

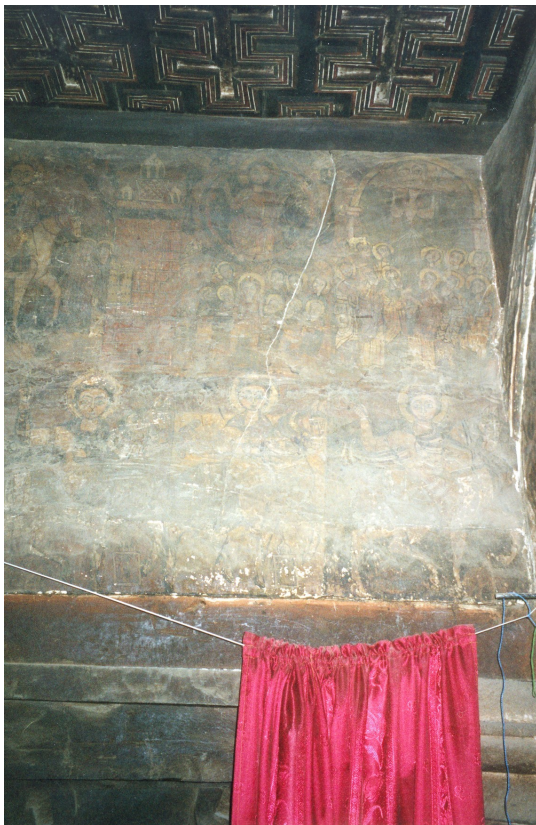
The paintings are very dirty and have a surface treatment of some kind of wax mixture. There are big diagonal cracks in the painted plaster. Paint is flaking in the girdle-arches and the ceiling and inventories of wood are in great need of cleaning. The painted ceiling has been partially damaged by smoke and fire.

The colour is flaking in the girdle-arches.

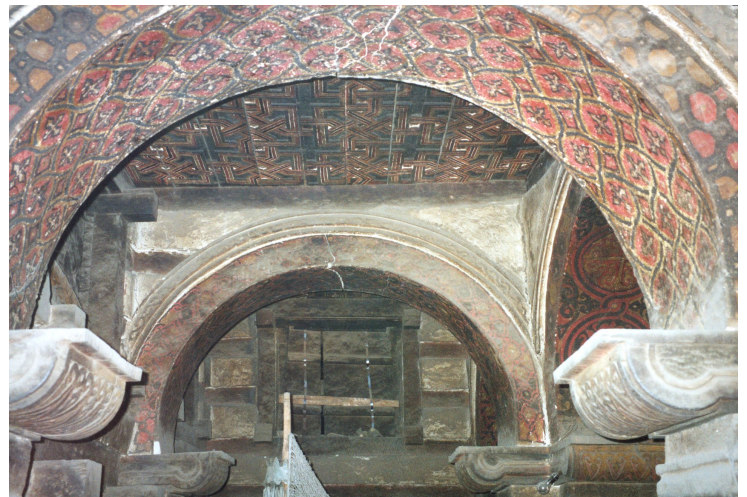
Very dirty mural-painting with a surface of wax. A crack goes straight through the plaster diagonally across the painting.

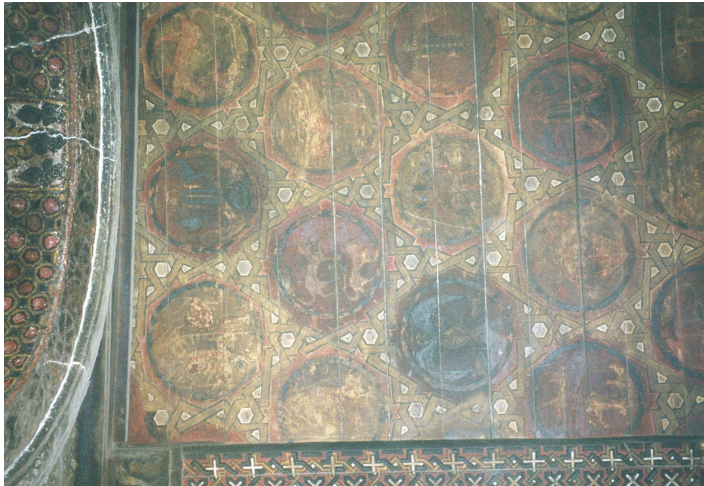
Ceiling damaged by smoke with hardly visible decorative painting.

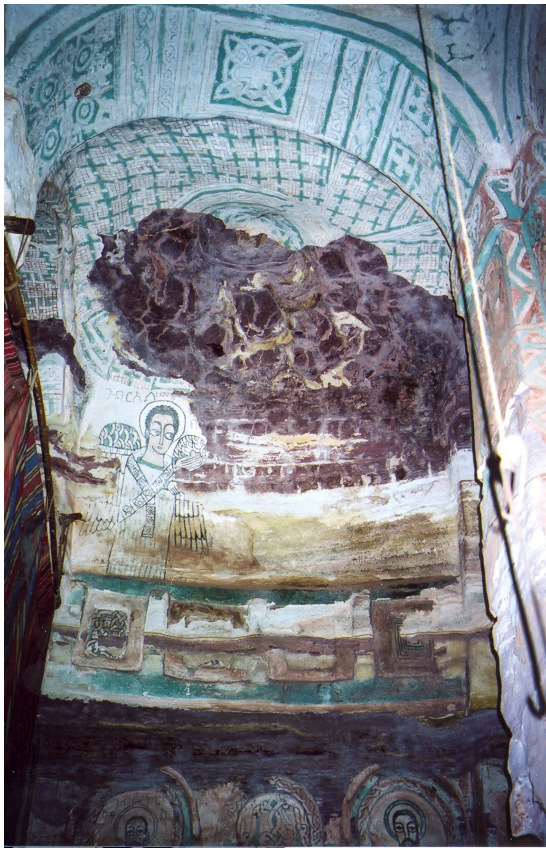
Everything here is in alarmingly bad condition. The stone is decomposing and where the painted plaster has not yet fallen there is great risk that this will happen soon. If nothing is done, all the paintings here will be lost. As the stone deteriorates, the plaster, covered with paintings, is loosening. This can only be helped by an impregnation of the stone itself. An impregnation process of that kind should take about one year. The roof has fairly recently been provided with a layer of concrete, as well as a water drain. There is a liturgical fan in relatively good condition, however in need of examination and restoration.

The stone is decomposing and the plaster is falling off.

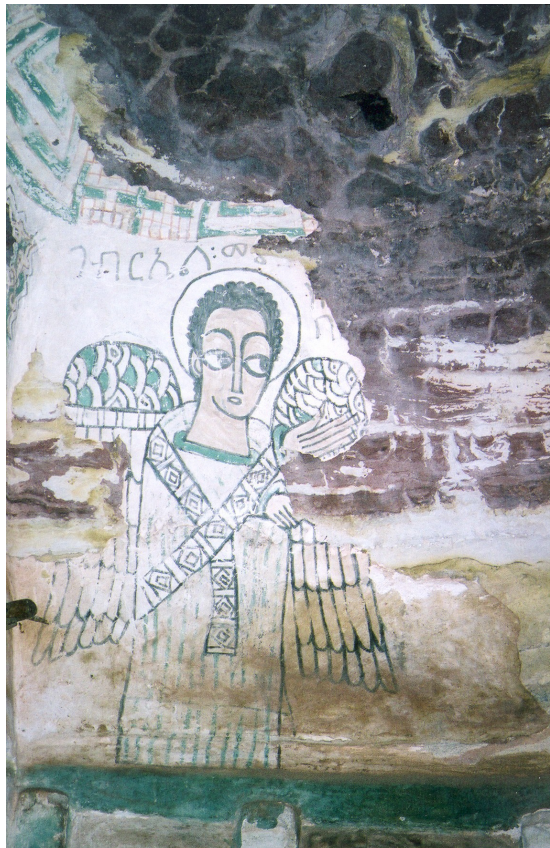
Detail: A lonely angel is still clinging firmly, but for how long?

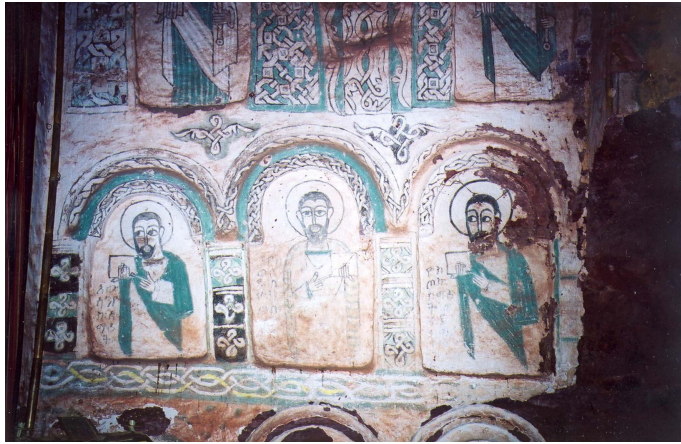
Three saints in the early stages of decay.

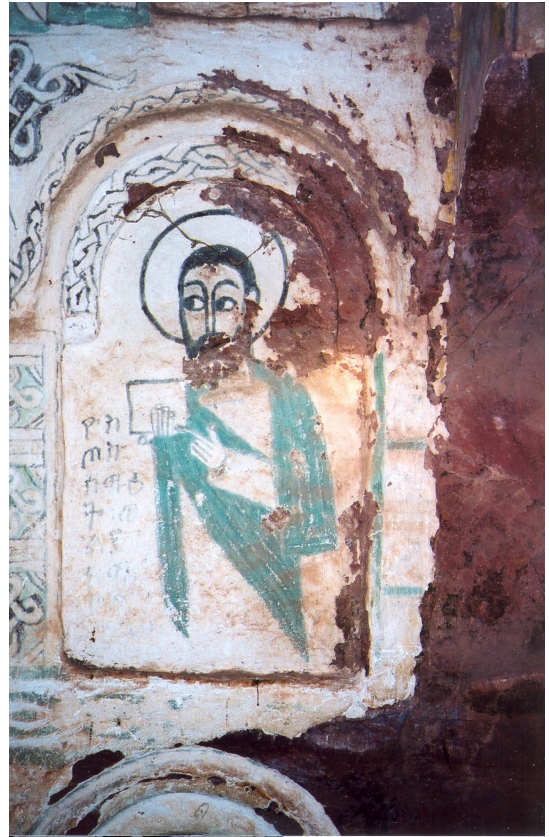
Detail: The plaster has started to fall, in the long run nothing will be left.

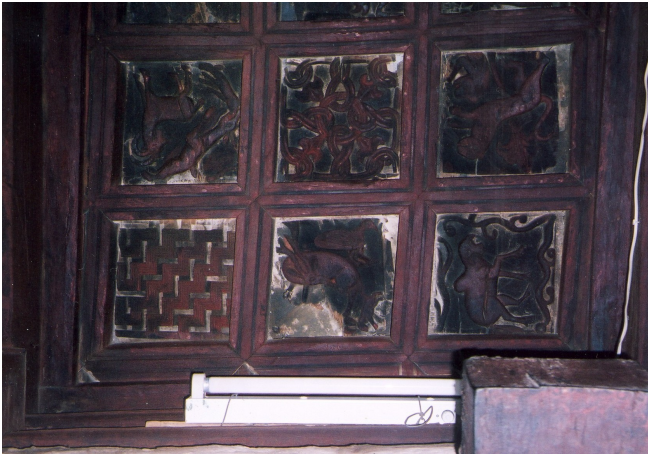
The famous animal reliefs in the ceiling of the narthex are decaying. The wood is drying out and piece by piece is falling down. Without impregnation and repair, these reliefs will be lost.

The wooden ceiling in the narthex. The reliefs are drying out and falling down.

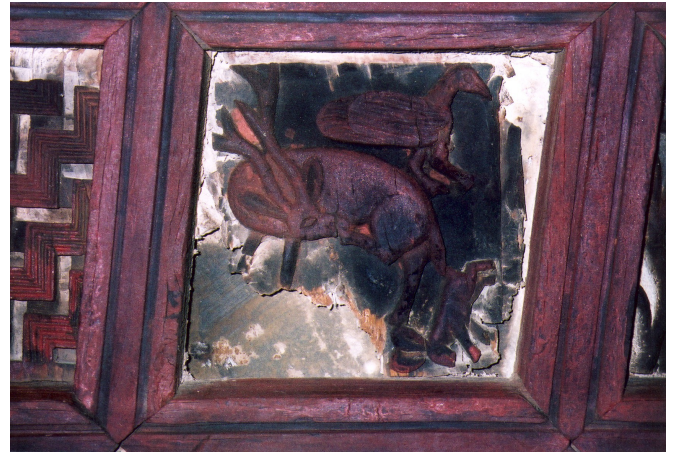
Detail: One of the reliefs which is decaying.

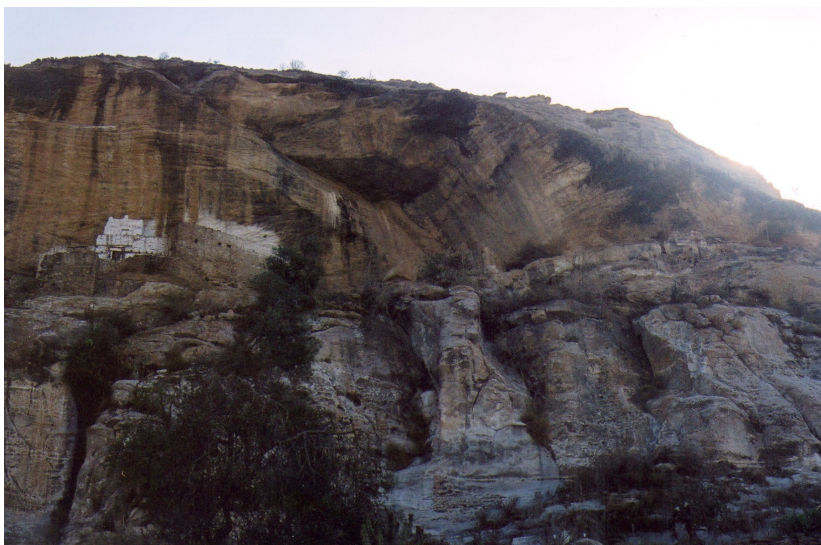
The entire building construction is in quite bad condition and this is also true of the roof. The paintings are relatively clean but in several places are in bad condition. The paint is falling off and there are large cracks; the plaster is loose in some places.

Exterior: This small church is placed on the edge of a cliff some way up in the mountains.

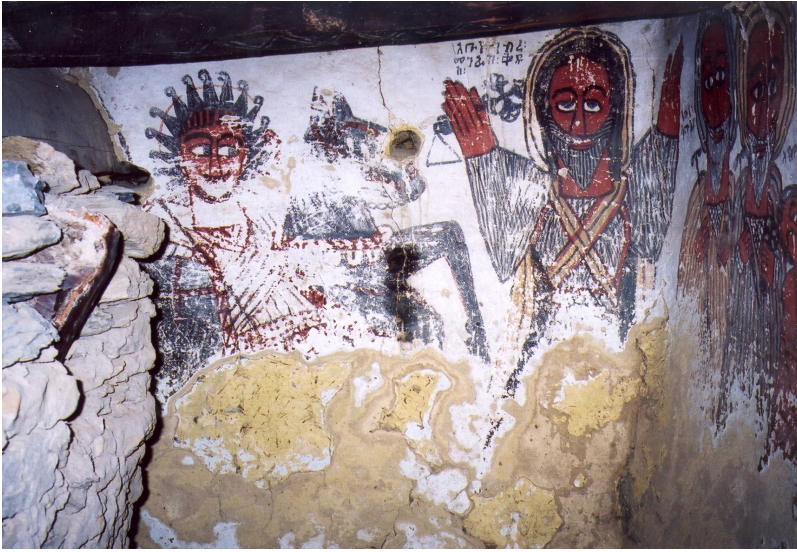
Extensive damage to wall and plaster.

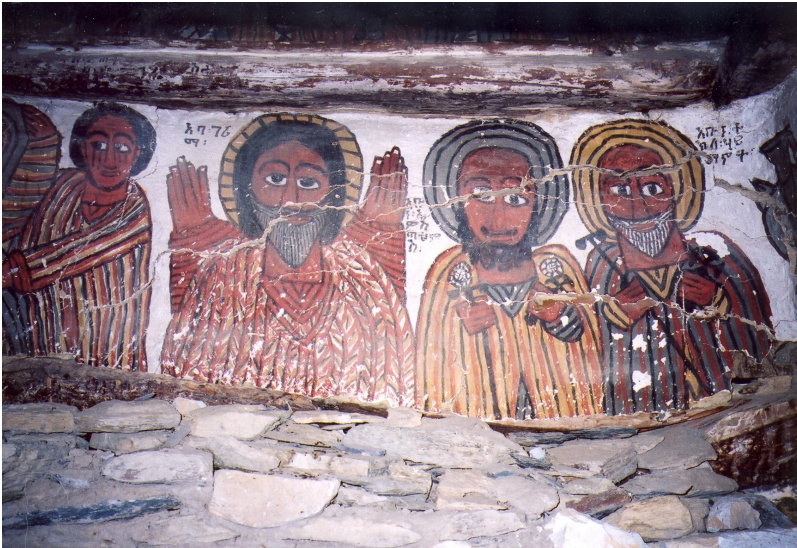
Cracks in the plaster and paint falling down.

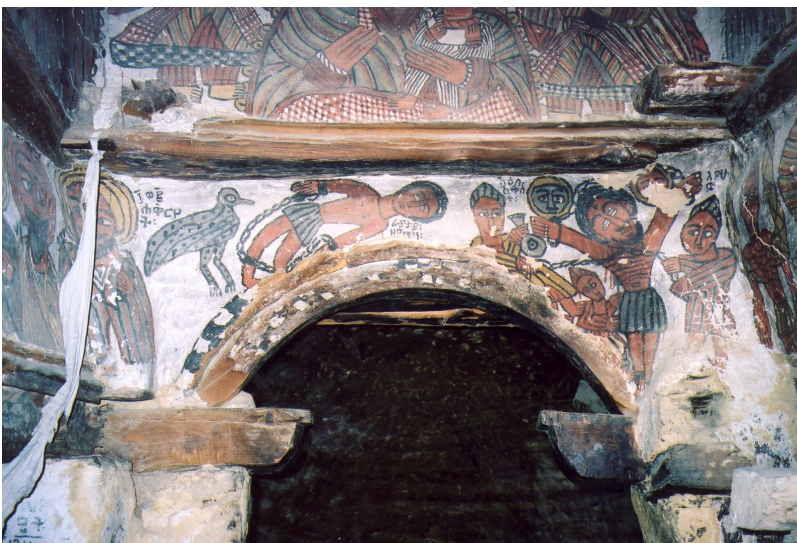
Large painted surfaces with paint falling off.
